Project Photogator

**NASA Student Launch 2023 Flight Readiness Review
Addendum**

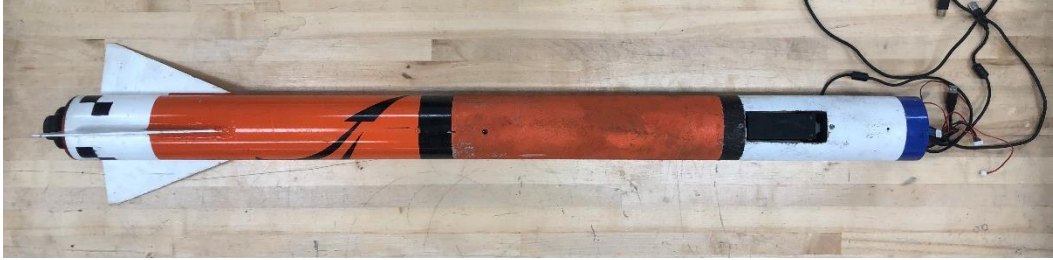
Figure 2: Payload Assembled in Launch Vehicle

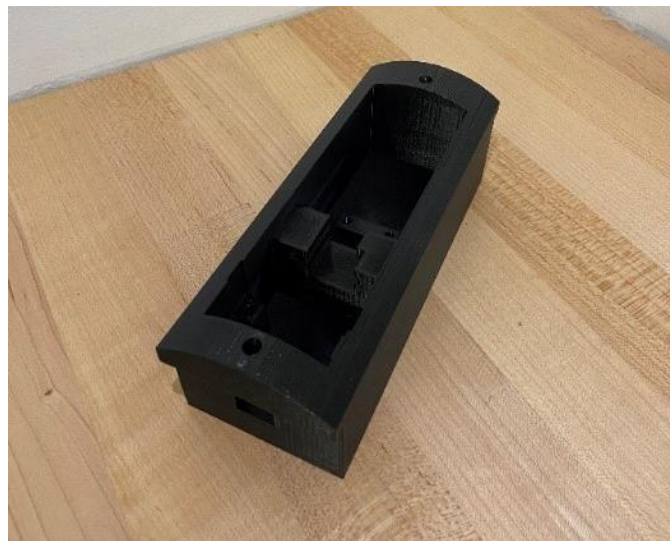
Figure 3: Payload Housing Retention

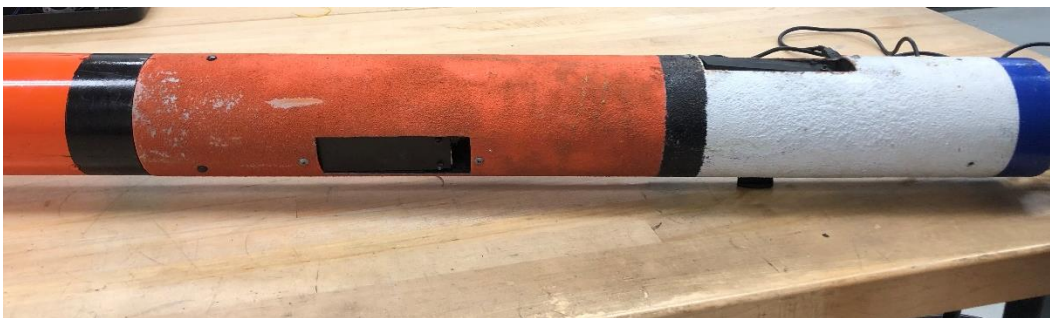
Figure 9: Payload Retained in Vehicle Post-Recovery
