Project Avigator

NASA University Student Launch Initiative 2024 FRR Addendum

University of Florida

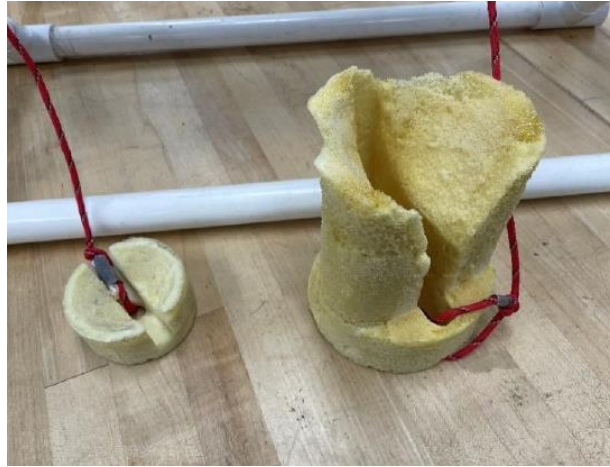
Figure 2: Payload Sabots

The payload is held within the launch vehicle during flight with sabots, which were made from two-part expanding foam. The forward sabot has a rounded pocket that interfaces with the spherical cockpit and contains a cutout to provide clearance for the central prop attachment. The aft sabot features a wedge-shaped pocket that matches the surface of the aft of the payload and contains a slot for the rudder to slide into. These components were tethered to the inside of the vehicle with a short length of paracord, allowing the sabots to remain within the launch vehicle after deployment of the payload (Figure 2).

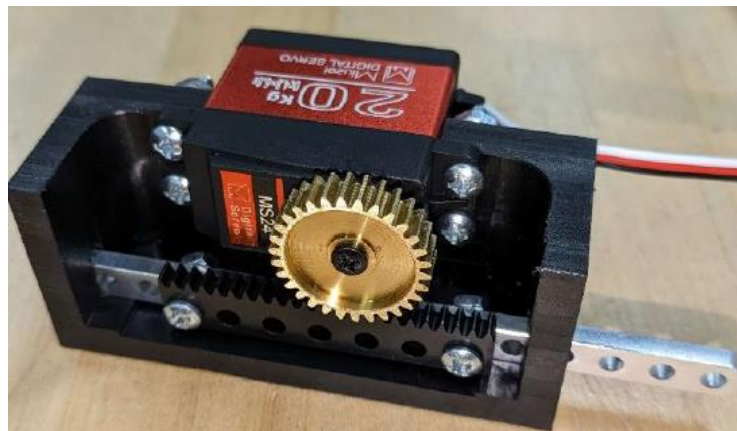
Figure 3: Rack and Pinion Mechanism Assembled

A set of two rack and pinion mechanisms were installed within the payload bay to control the ejection of the payload (Figure 3). The rack and pinion mechanism consists of a Miuzei 20kg servo motor attached to the servo mount. A pinion gear attached to the spline of the servo motor, which interfered with the teeth of the gear rack, allowing it to move linearly. A gear rack fastened to the flat beam, with its linear actuating movement being constrained within a servo mount.

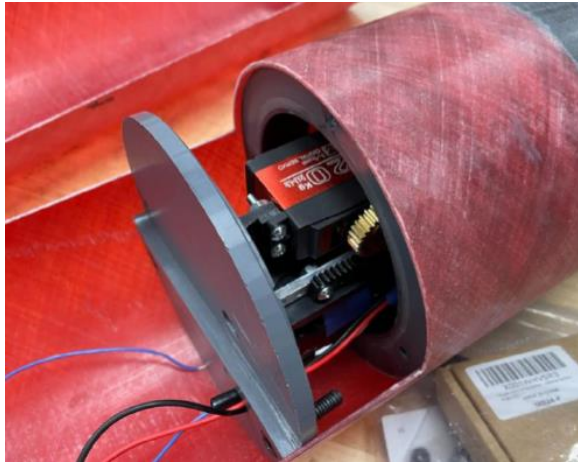
Figure 4: Aft Payload Bulkhead with Payload Retention System Electronics Mounted to the Aft End

The rack and pinion mechanisms used for the payload retention system were epoxied with JB Weld onto the payload forward and aft bulkheads (Figure 4). The battery powering these mechanisms was also epoxied onto the payload aft bulkhead. Once the battery was connected, the wires and recovery harness for the aft sabot passed through a hole on the payload aft bulkhead. This bulkhead was then fastened into the forwardmost centering ring of the transition assembly with two 1/4-20 head screws (Figure 5).

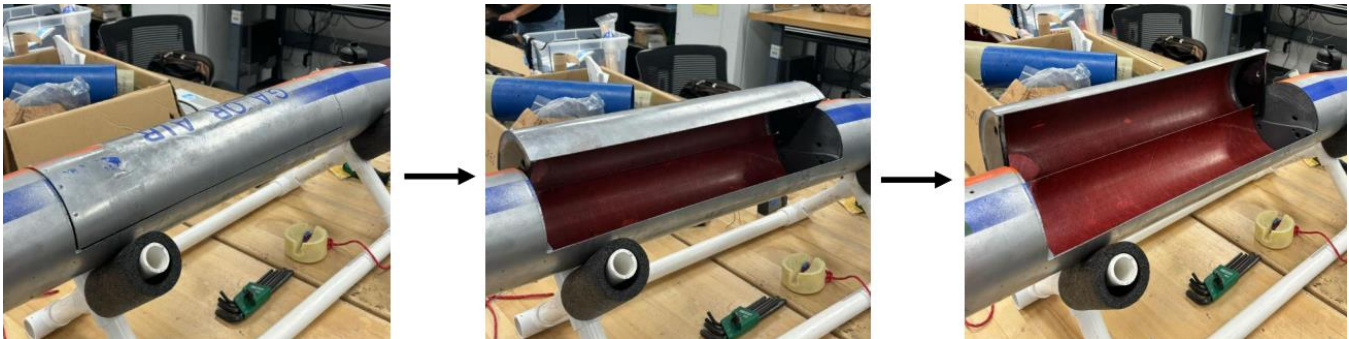
Figure 6: Payload Door Assembly Hinging Opened

The payload door assembly was then fastened to the payload forward and aft bulkheads with shoulder screws. This point acts as the pivoting point of this assembly for the door to open and close (Figure 6).

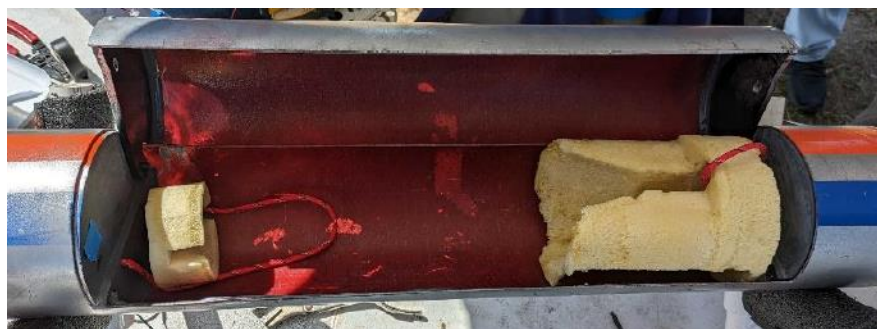
Figure 7: Sabots Attached to Launch Vehicle with Recovery Harnesses

Once the payload retention system was fully assembled, the payload was rolled and placed within the payload bay (Figure 7). However, while preparing the payload retention system during demonstration, the forward sabot, which held the front side of the payload, was removed. This was necessary because it interfered with the propeller assembly and prevented the payload from fitting completely inside the payload bay (Figure 8).

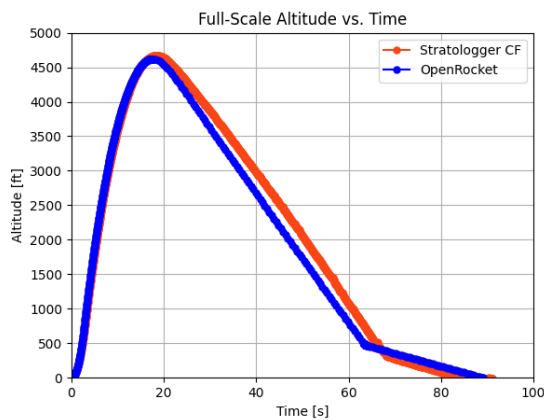
Figure 9: PDF Resulting Altitude vs. Time

During flight, two altimeters were utilized. The main altimeter was the Stratologger CF, and the secondary altimeter was the MissileWorks RRC3. Due to an error in the secondary altimeter where the data written during flight failed to save, only data from the main altimeter was available for the Payload Demonstration Flight. Despite this failure to write data, both the backup ejection charges connected to the backup altimeter successfully detonated. The altitude and velocity profiles of the OpenRocket simulation and the Stratologger CF flight data are shown in Figure 9 and Figure 10. Some noise is present in the velocity flight data during the descent under drogue, and especially around the time of main parachute deployment, but this noise was deemed insignificant and was caused by the fast-sampling rate, which propagated small errors in the measured altitude to larger velocity deviations.

Using the altitude and velocity profile data from main altimeter, the Stratologger CF, the apogee of the flight was calculated along with the average drogue and main descent rate upon landing. The drogue and main descent rates deviated from the predicted simulation by 3.4% and 0.6% respectively (Table 4). This increase in descent rate led to a decrease in the descent time from the predicted time by 7.9 s, or 10.4%.

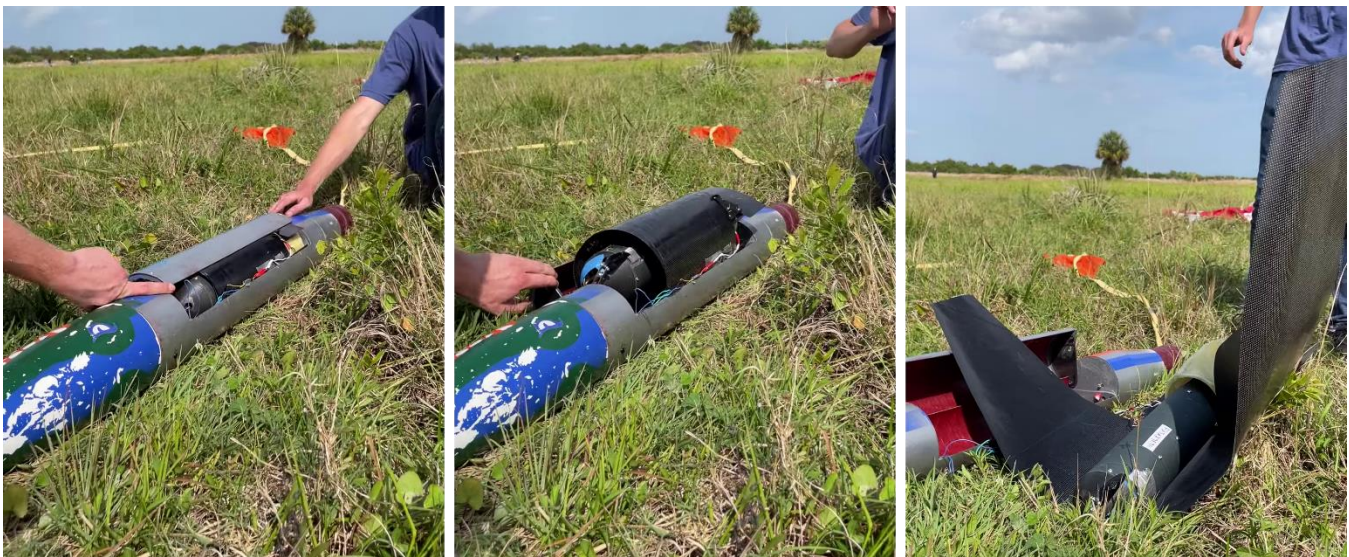
Figure 21: Demonstration of Intended Payload Deployment

After the documentation of the launch vehicle recovery, the payload was investigated to identify the cause of failure. Deployment of the payload was caused manually to identify the issue of the payload becoming stuck within the bay (Figure 21).

The wing and all control surfaces rolled properly and allowed for the payload to be loaded into the launch vehicle. However, the wing caused the payload to get lodged in the launch vehicle when the payload door opened, so the payload did not deploy. When the wing unfurled, it pressed against the inside of the launch vehicle, preventing the payload from deploying.

The only mechanical system that failed was the wing. The wing caused the payload to become lodged in the launch vehicle and prevented the payload from deploying. Due to the payload not deploying, full payload functionality was unable to be demonstrated.

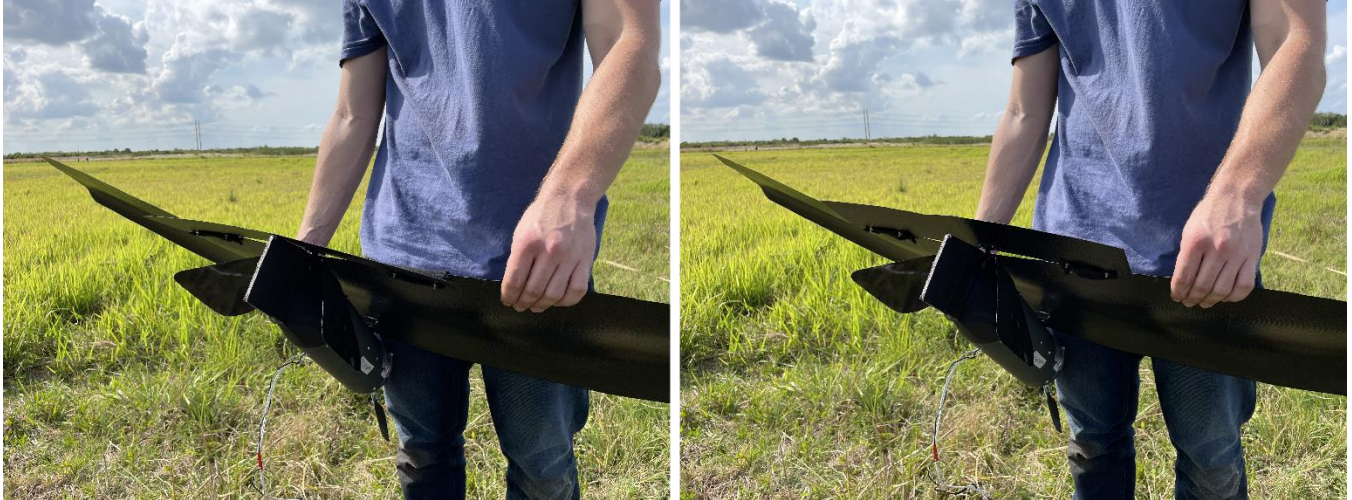
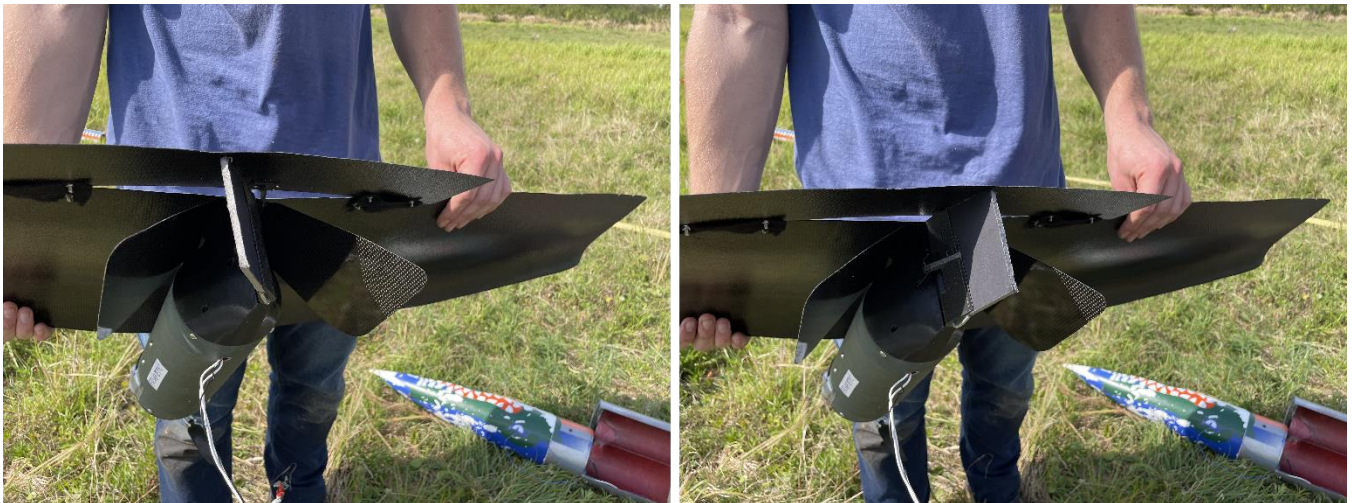
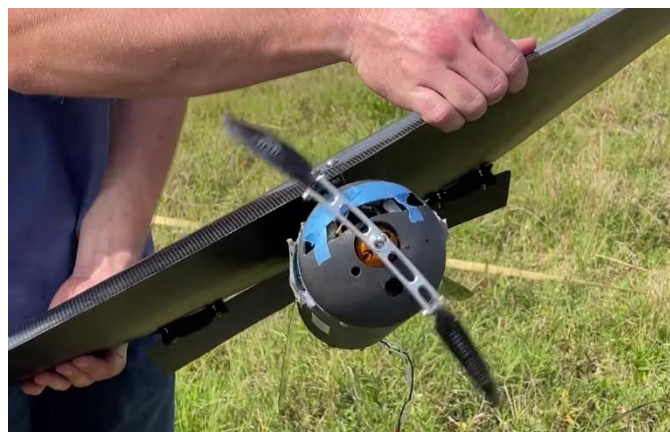
Then, the elevator, rudder, and propeller motors were actuated using the remote controller to verify functionality after flight. These systems were functional, demonstrating that the payload would likely have functioned nominally if deployment had succeeded.

After removing the payload from the launch vehicle, all mechanical system worked properly. The propeller, elevator, and rudder systems were tested, and all were functional. The payload also did not sustain any structural damage to the wing, control surfaces, or fuselage.

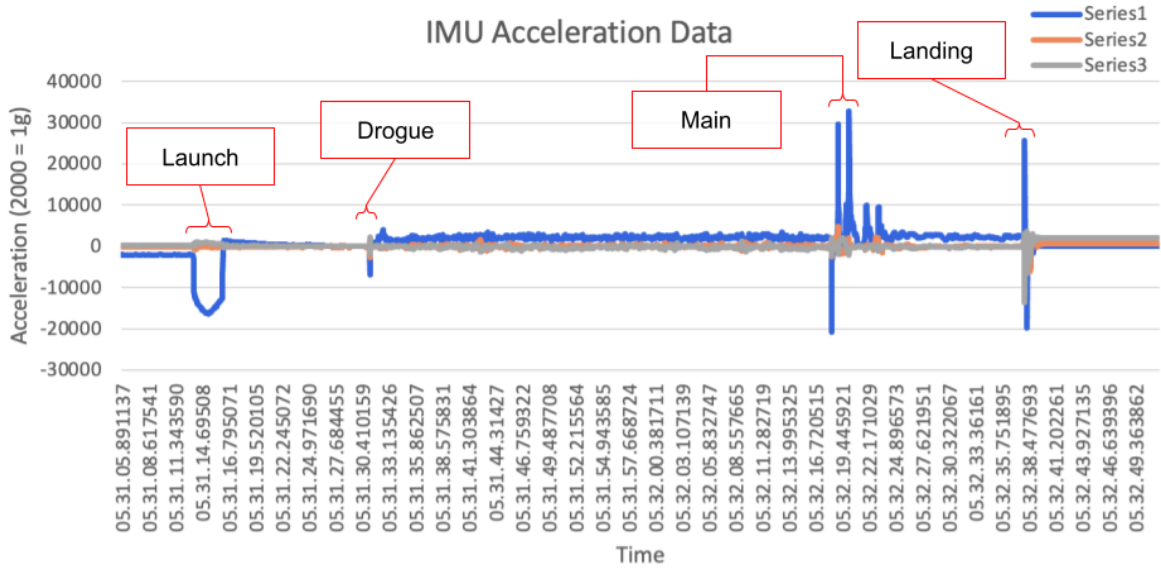
Figure 25: IMU Acceleration Data

All three figures show the same time frame of the data log, zoomed in on the launch. Timestamps are formatted as HH.MM.SS.millisecond. The series in Figure 25 represent the x, y, and z axes, respectively. The x axis is parallel to the length of the launch vehicle, and thus was the axis reporting the bulk of the acceleration forces from launch, parachute deployments, and landing. The units reported by the IMU can be converted to g-forces following the conversion 2000 units = 1 g. This conversion was verified through testing (P-A-11).

There was no five second period of g-forces larger than 9gs, meaning that according to the survivability criteria, the STEMnauts survived the flight. 9gs was not exceeded for more than a few milliseconds each time.

The Raspberry Pi functioned as intended. It was able to collect data from the sensor suite, log flight information, and detect launch. The flight controller was also activated. Figure 25, Figure 26, and Figure 27 show the sensor data recovered from the launch.

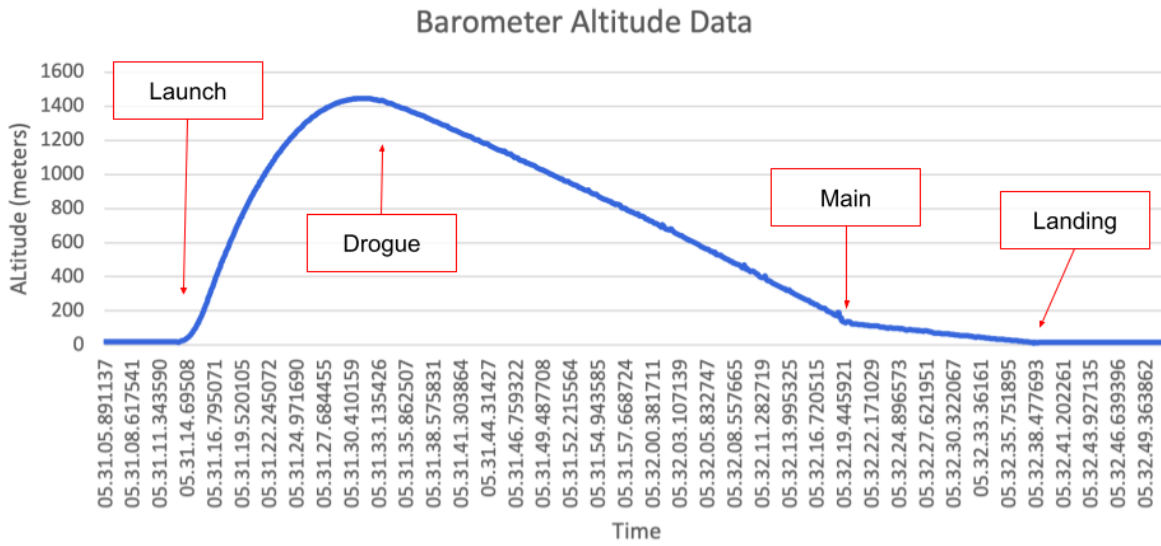
Figure 26: Barometer Altitude Data

The altitude data, adjusted for temperature readings, is consistent with readings from the launch vehicle altimeters, reporting an apogee of 4685 ft.

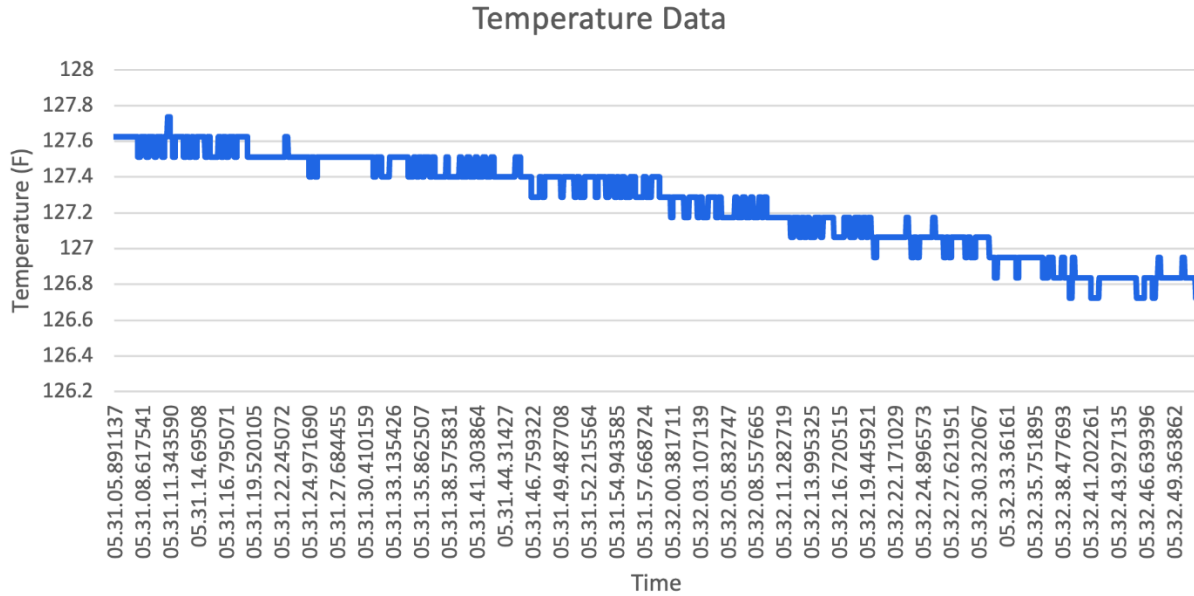
Figure 27: Temperature Data

The temperature on the payload never exceeded 132.2 °F (this maximum was reached at a time prior to the section shown in Figure 27), meaning the payload was within a safe temperature range the entire mission, and nothing was turned off.
